CSI Client Advisory 09-2021

SUBJECT: Accommodation Ladder Turntable Pin Failures

Safety Alert 05-21

CORRODED TURNTABLE PINS CAN CAUSE STRUCTURAL FAILURE ON ACCOMMODATION LADDERS

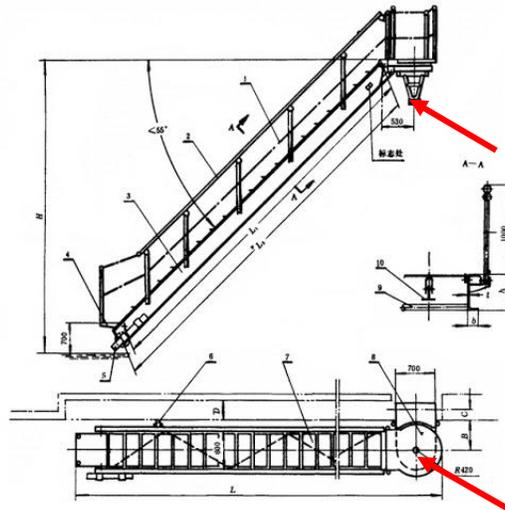
Figure 1: Pin location on the Accommodation Ladder Turntable

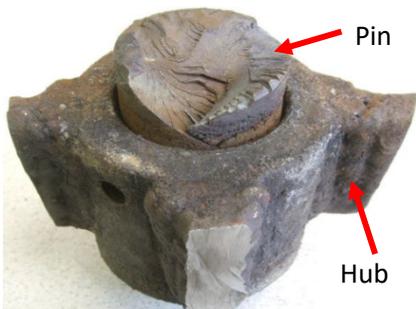
While the turntable pin may seem like a minor component, its failure can cause significant harm to all persons utilizing the accommodation ladder. In this instance, the vessel's crew was in the process of stowing the accommodation ladder when the turntable pin failed. As a result, a crewmember who was on the accommodation ladder at the time fell approximately 30 feet and sustained serious injuries.

Figure 2: Accommodation ladder connection pin with severe corrosion over the pin's fracture surface & sidewall and on the surface of the hub.

The Coast Guard **strongly recommends** that vessel owners and operators:

- Maintain the turntable pins.
- Periodically inspect the condition of the turntable pins and replace them when necessary.
- Revise accommodation ladder maintenance plans to include turntable pins.

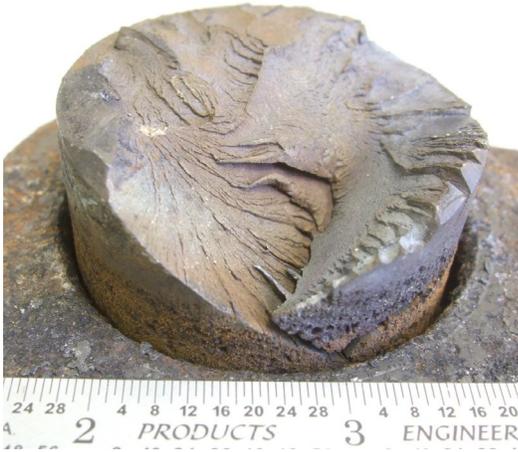
Figure 3: Surface corrosion and contamination are evident on the fracture surface of the failed turntable pin. Severe corrosion pits and surface cracks are also visible on the sidewall, which could have provided an indicator of the pin's unsafe condition prior to failure.
